**LOWER MILL CREEK  
HABITAT AND PASSAGE  
ASSESSMENT**

CONFEDERATED TRIBES OF THE  
UMATILLA INDIAN RESERVATION

# Mill Creek Timeline

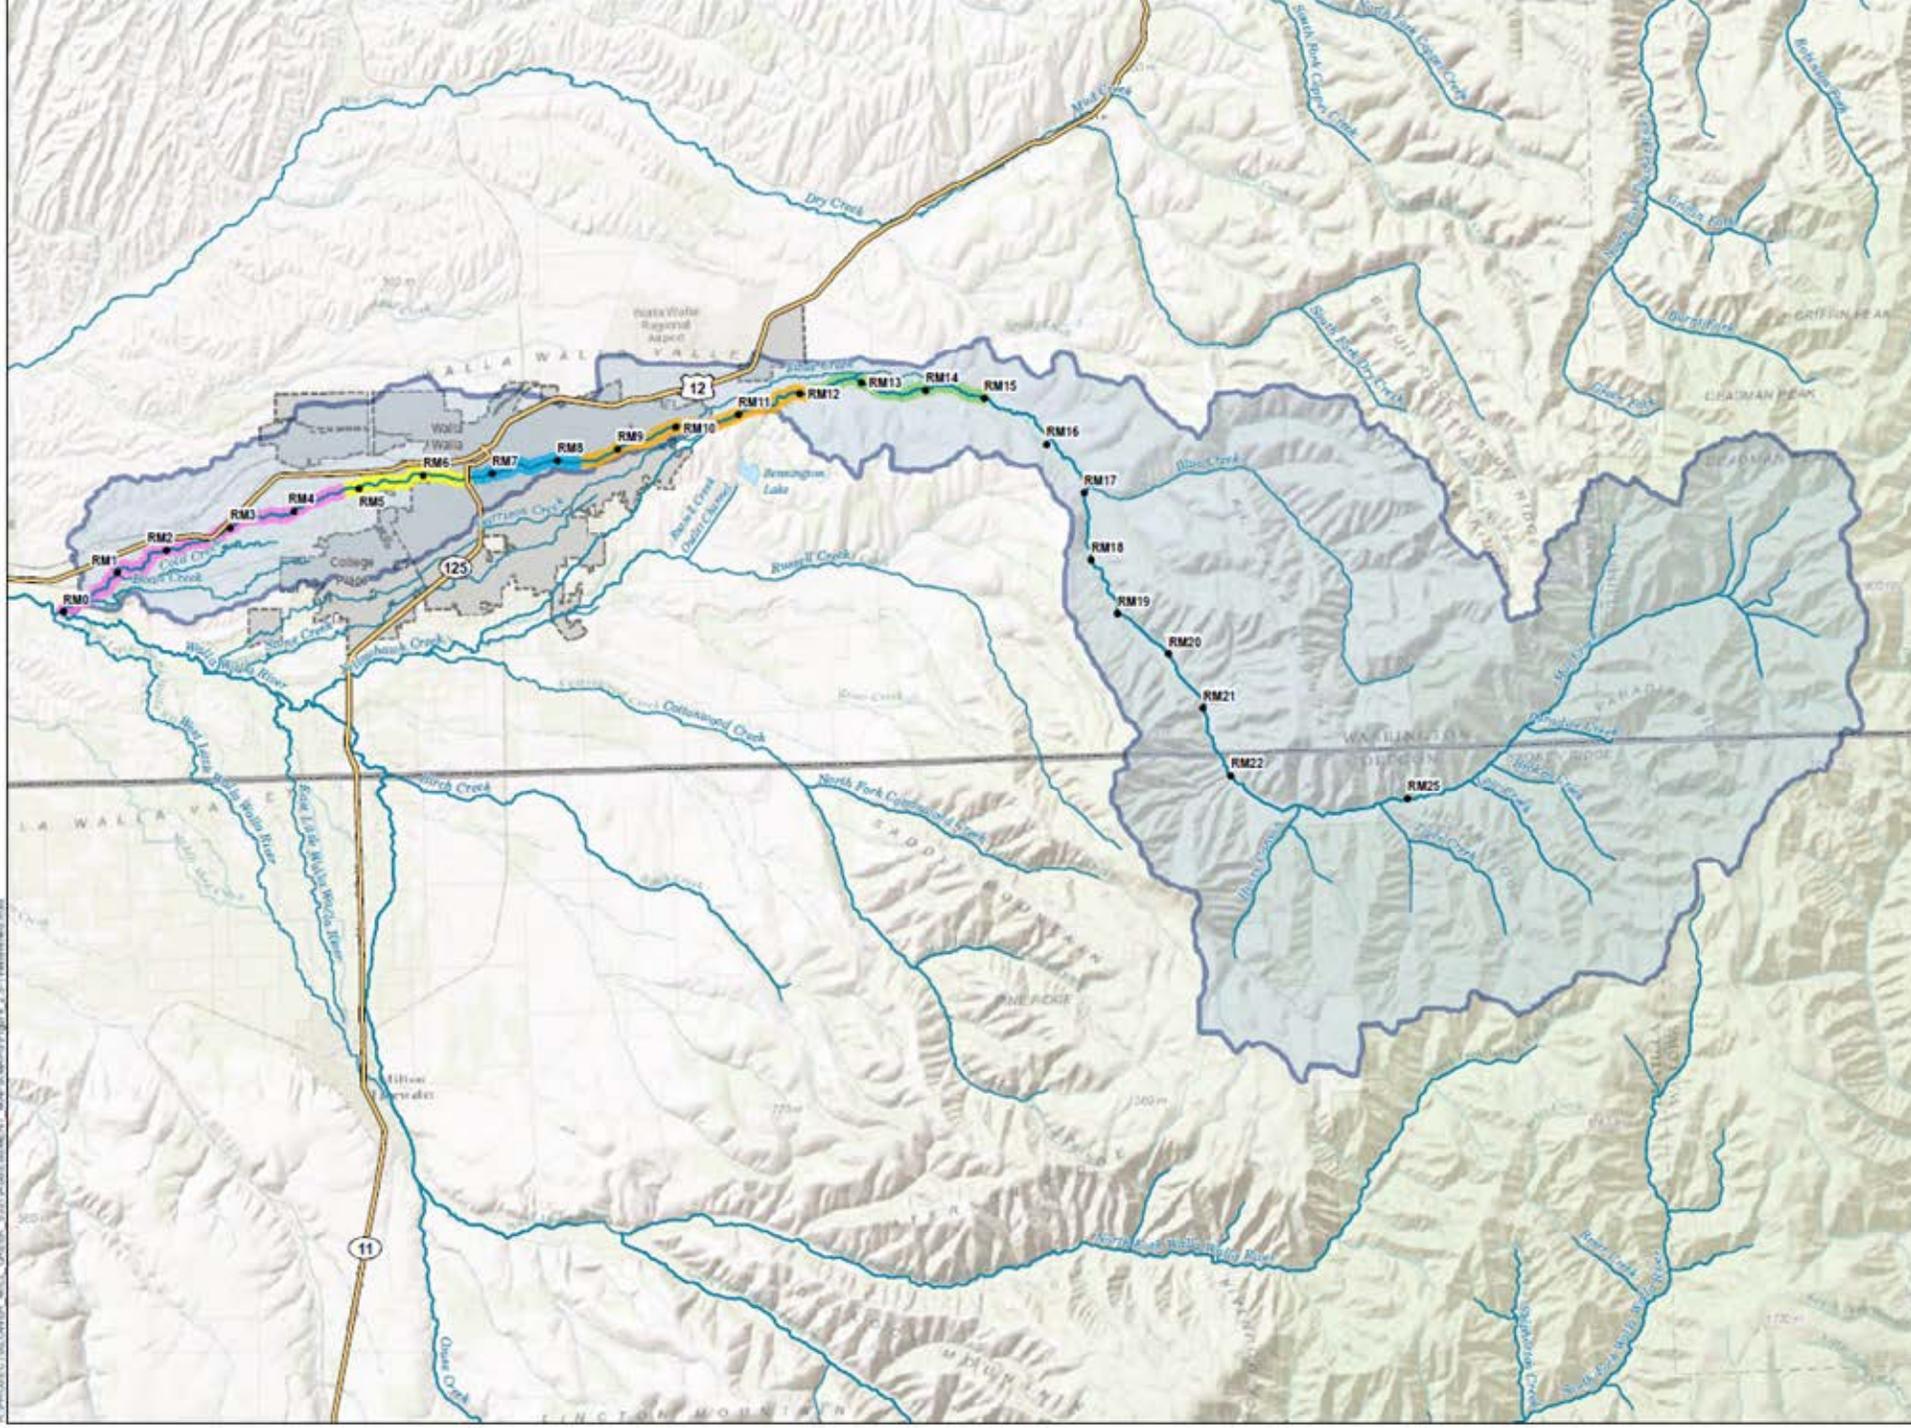
**FIGURE 2.5-1  
MILL CREEK WATERSHED**

- River Miles
- Major Stream
- Segment 1
- Segment 2
- Segment 3
- Segment 4
- Segment 5
- Waterbody
- Mill Creek Watershed
- Cities

PROJECT: OMPA - MILL CREEK - HABITAT AND PASSAGE ASSESSMENT - MAP 2.5-1 (Revised 2014)

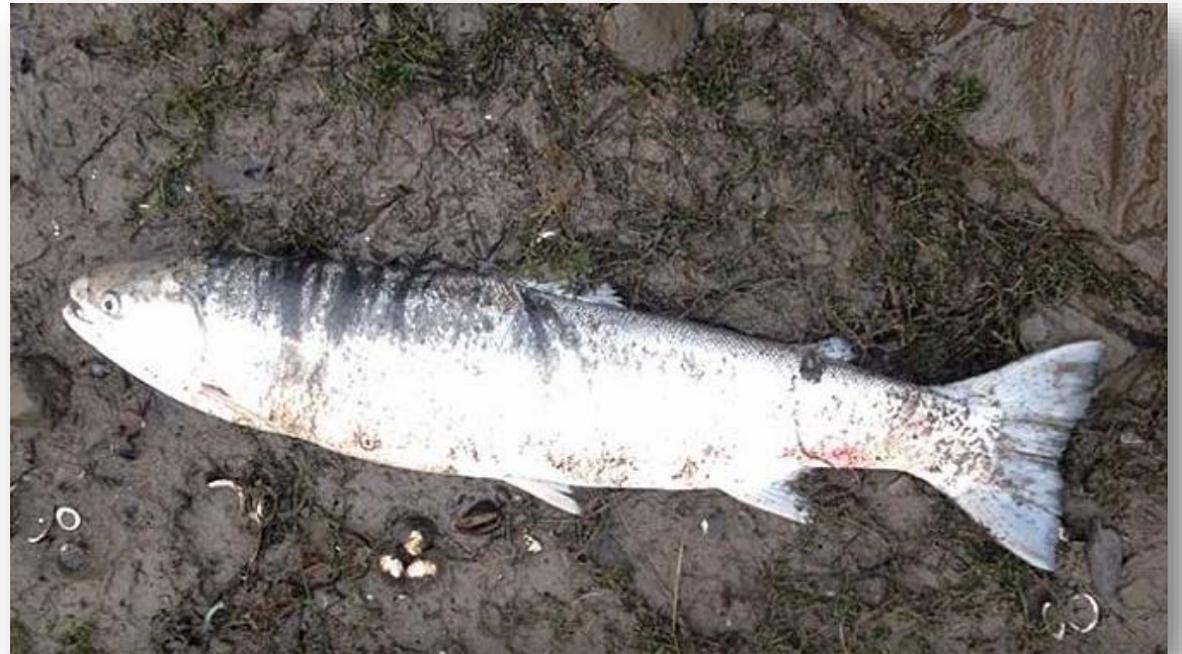
- 2002 – 16 dead adult steelhead observed at Bennington Diversion; bull trout too
- 2002 – Mill Creek Working Group formed

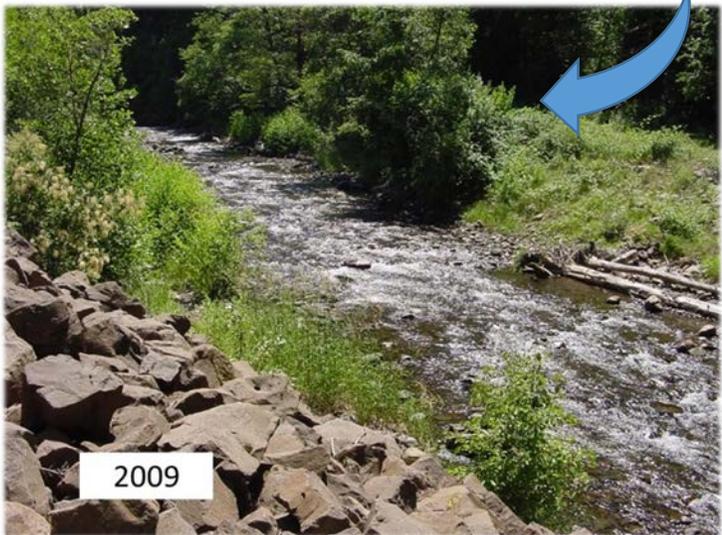
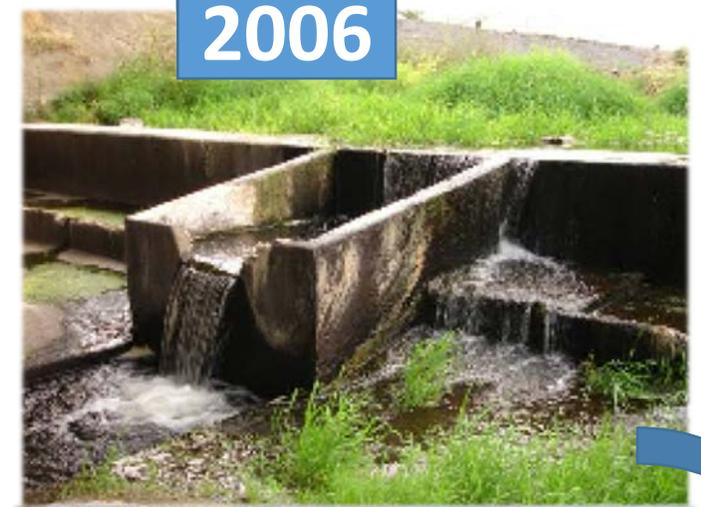
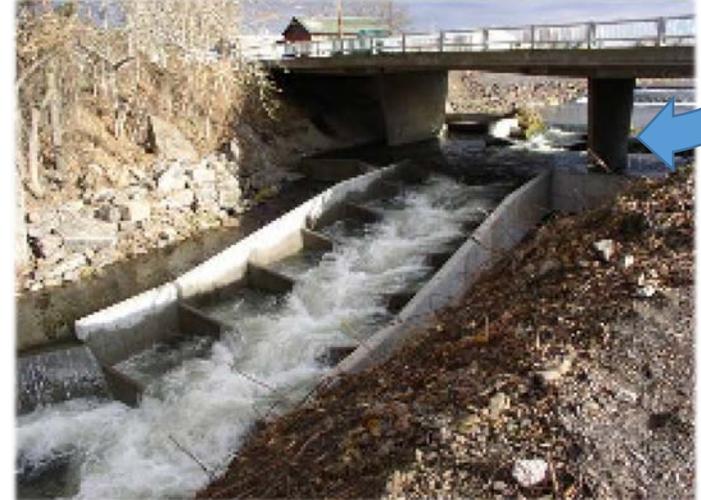
2006-Gose Street Passage Project

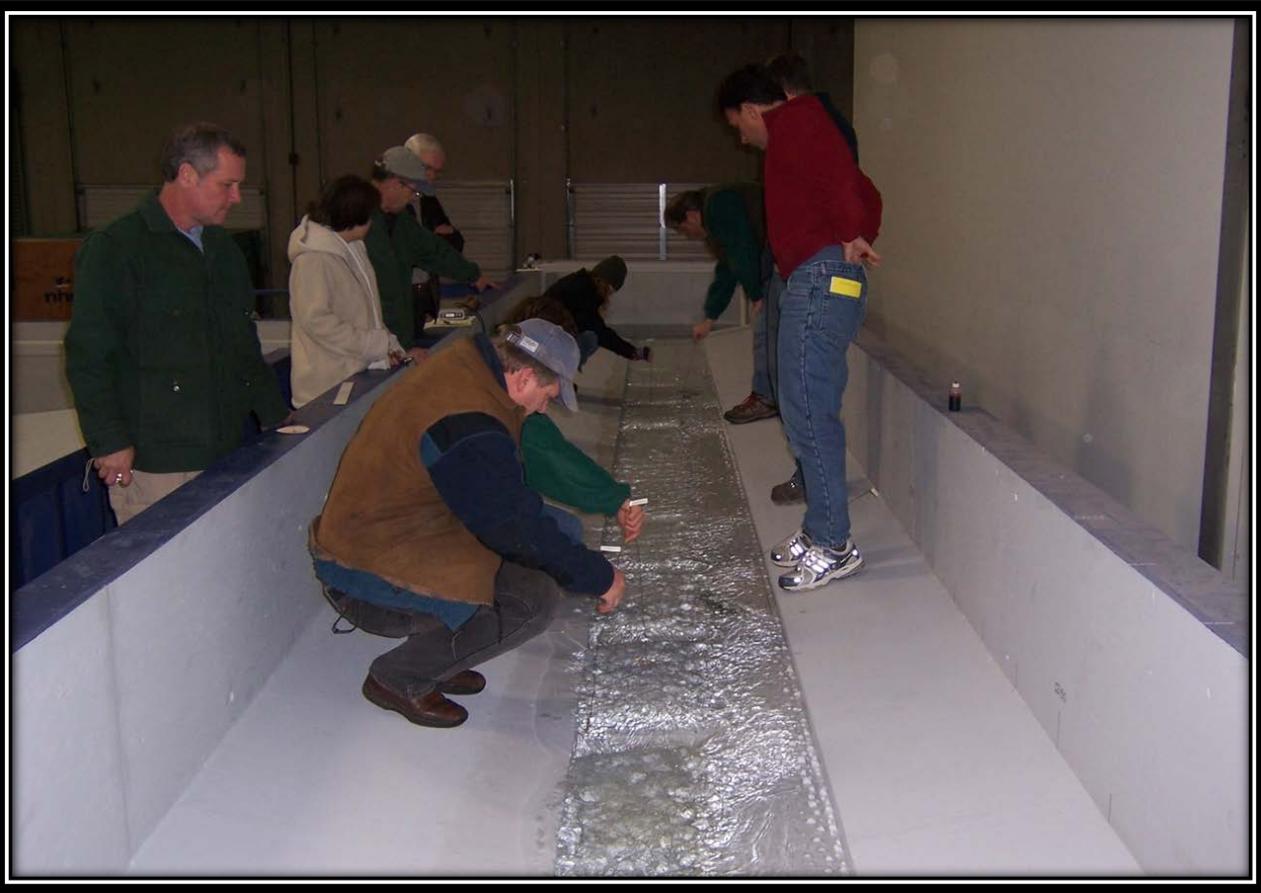
2009 – Mill Creek Passage Assessment

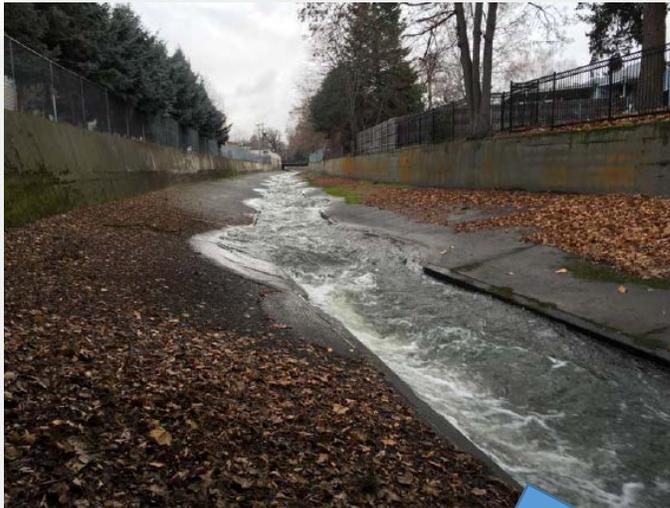
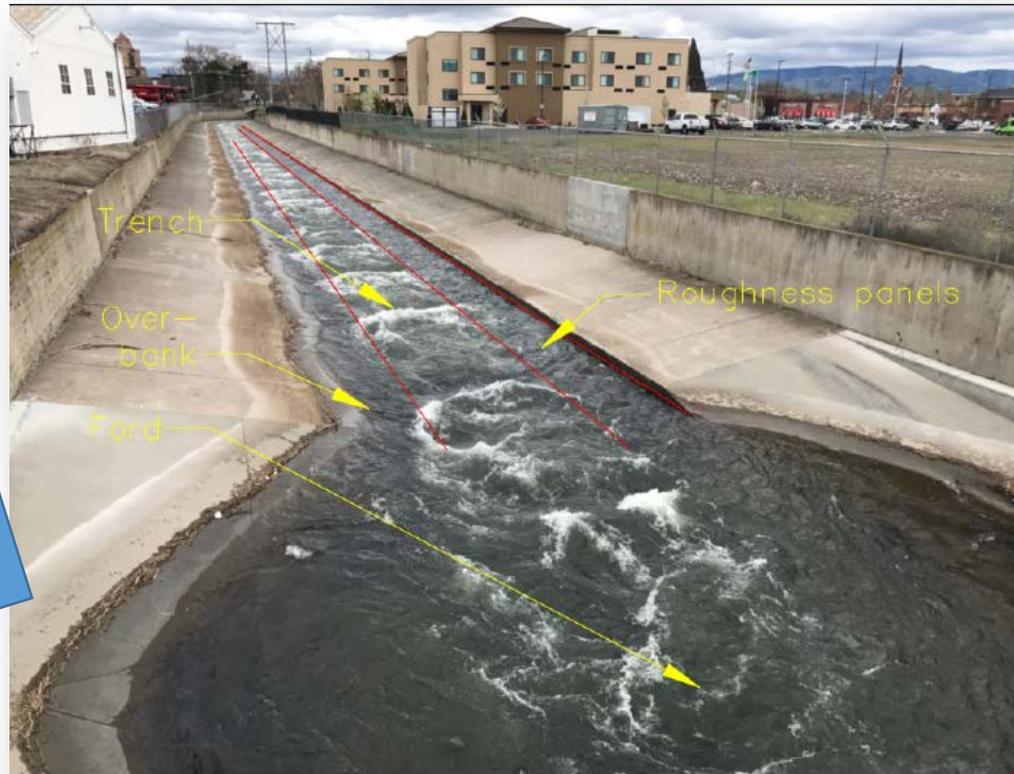
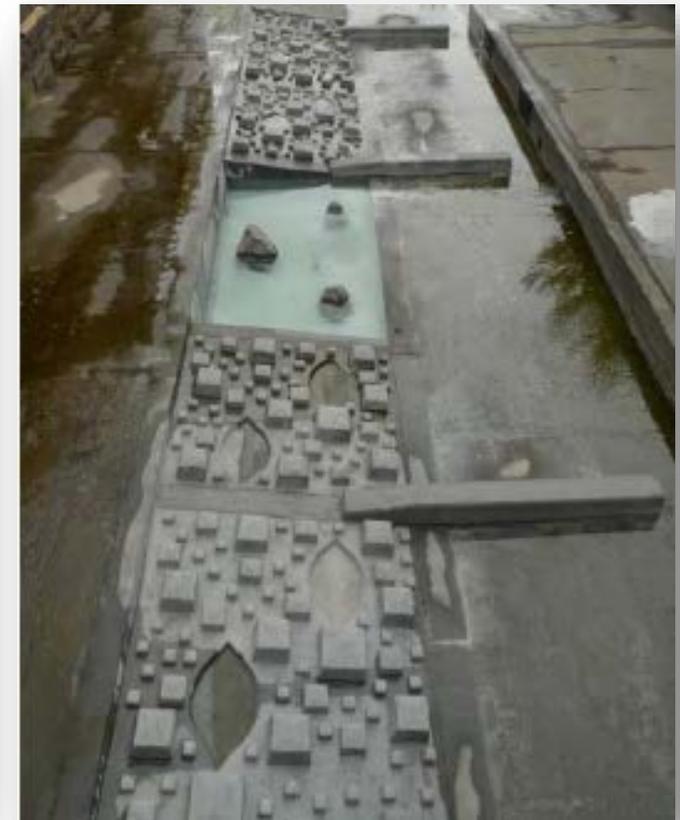
2011-2013: portions of the concrete channel were retrofitted for passage; pilot weir-notching and low flow channel completed

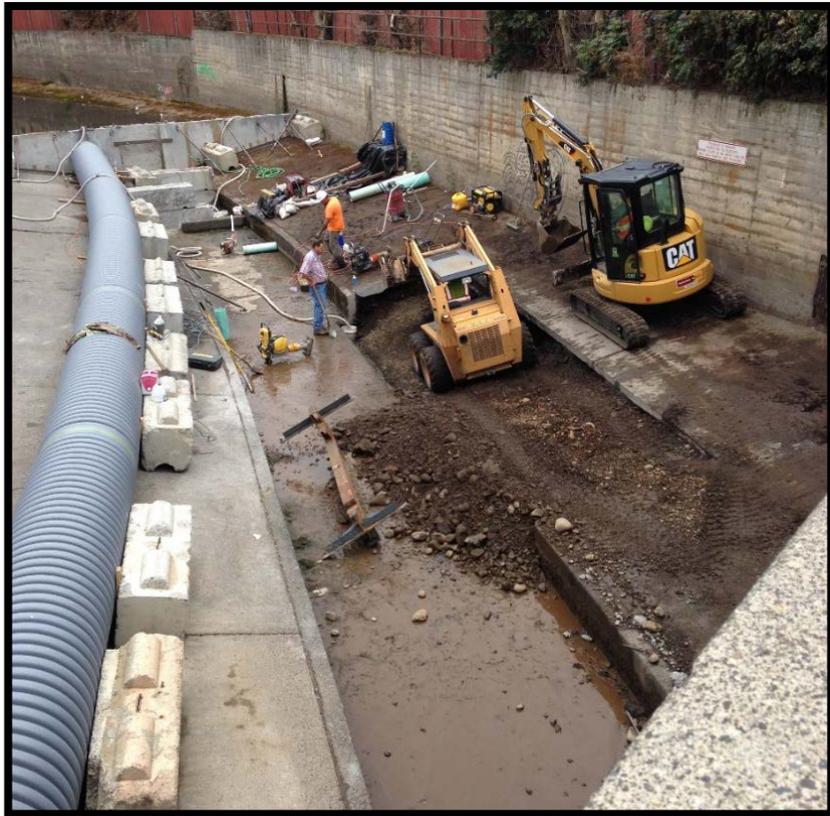
2014-2016 – 1,000 ft. of concrete channel designed and completed
